Report on the accident at Windscale No. 1 Pile on 10 October 1957^{*}

William Penney^{1,6}, Basil F J Schonland^{2,6}, J M Kay^{3,6},
Jack Diamond^{4,6} and David E H Peirson^{5,7}

1. You appointed the Committee of Enquiry on the 15th October with the following Terms of Reference: 'To investigate the causes of the accident at Windscale No. 1 Pile on 10th October, 1957, and the measures taken to deal with it and its consequences; and to report'.

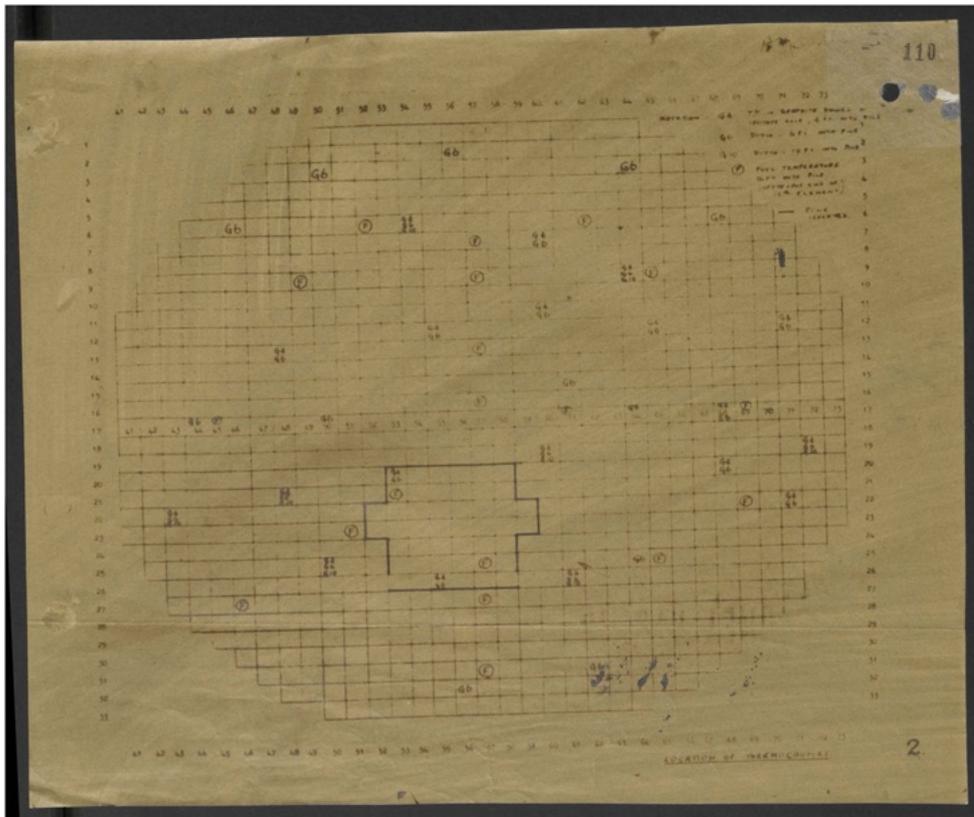
Appendix B. Location of thermocouples

* The location of the uranium and graphite thermocouples is shown at appendix B.

20. (It should be noted that the positions of the uranium thermocouples correspond to the readings of maximum temperature during normal operation, but that these are not the positions of maximum uranium temperature during a Wigner release (see also paragraph 42 below).)

101. A major technical defect contributing to the accident was the inadequacy of instrumentation for the safe and proper operation of a Wigner release. The uranium thermocouples were correctly positioned for normal operations, but not for Wigner releases; moreover, in the condition of stagnant air which had necessarily been created within the pile, there was no means of detecting the smouldering uranium cartridges, which we believe to have been a key event in the development of the accident.
